**Hillside Place Condominiums
Building Envelope Investigation
New Britain, CT**

1/25/2010

Prepared for: Hillside Place

In October of 2009 this office conducted a visual survey of the building envelopes of the main and annex structures at the Hillside Place Condominiums in New Britain, CT. The following report summarizes our findings.

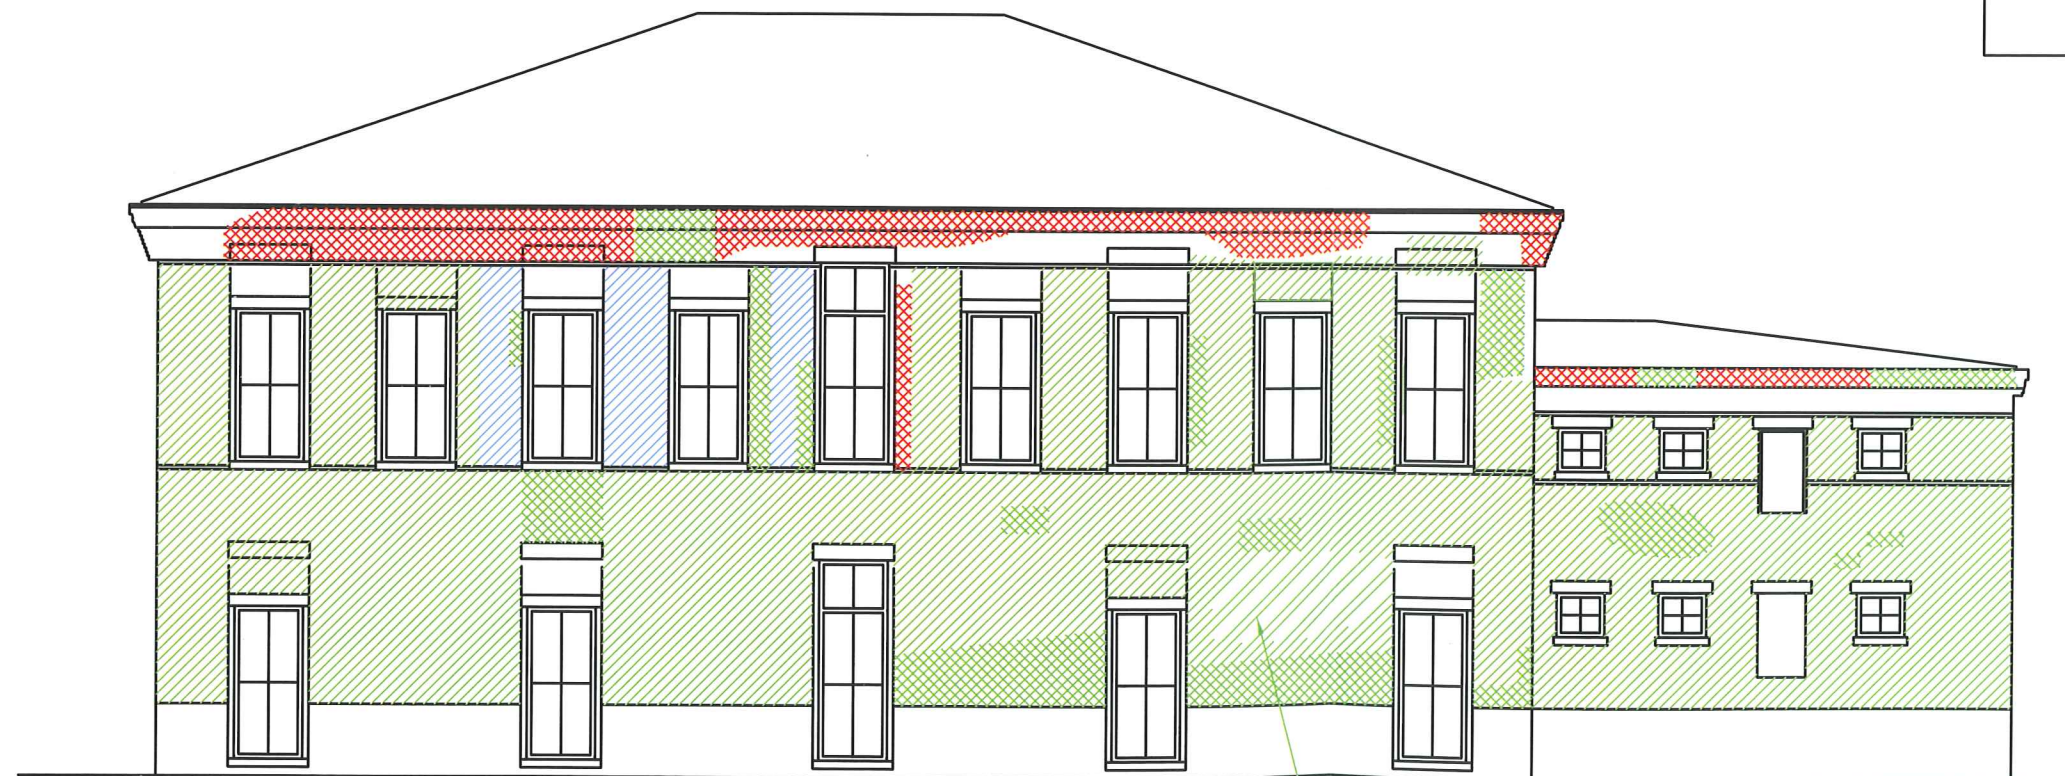
WEST ELEVATION - ANNEX
 NTS

2-E
 (75,25)

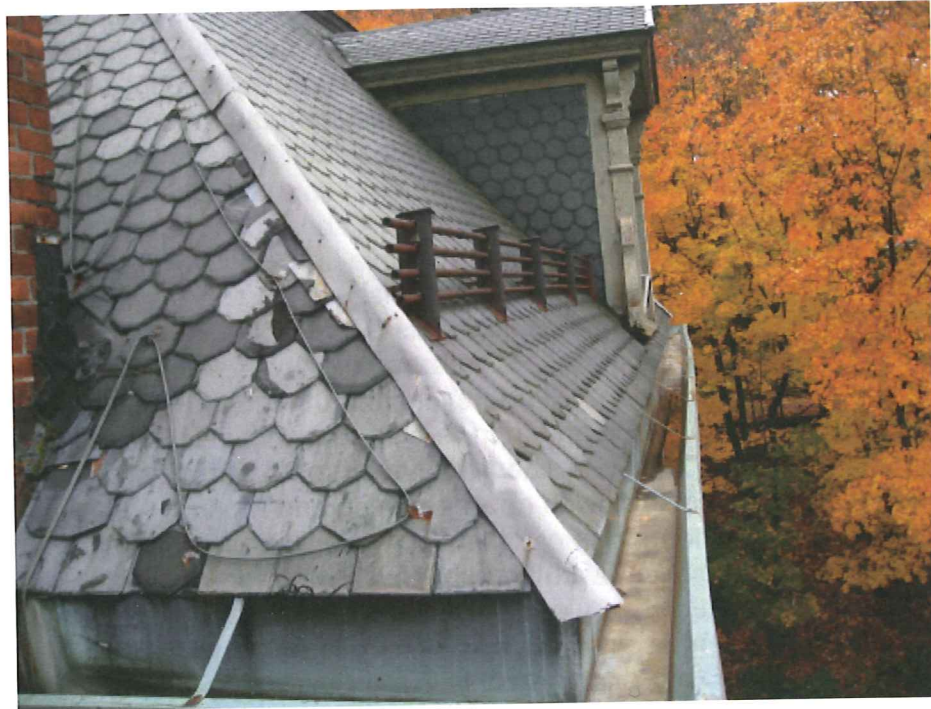
Replacement roof slates and failed ridge cap flashing

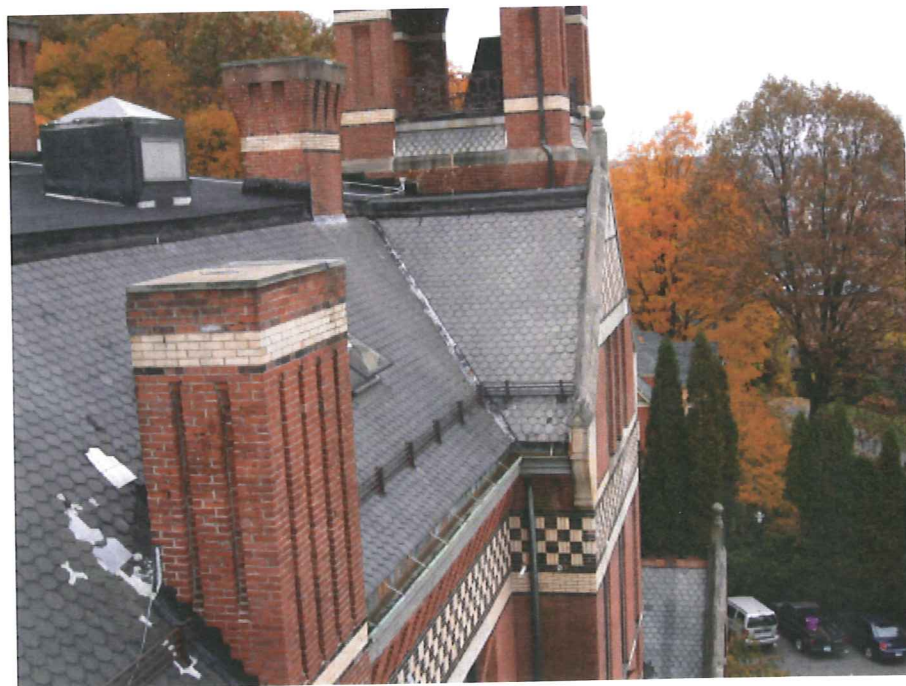
Broken and missing roof slates at chimney base with deteriorated flashing

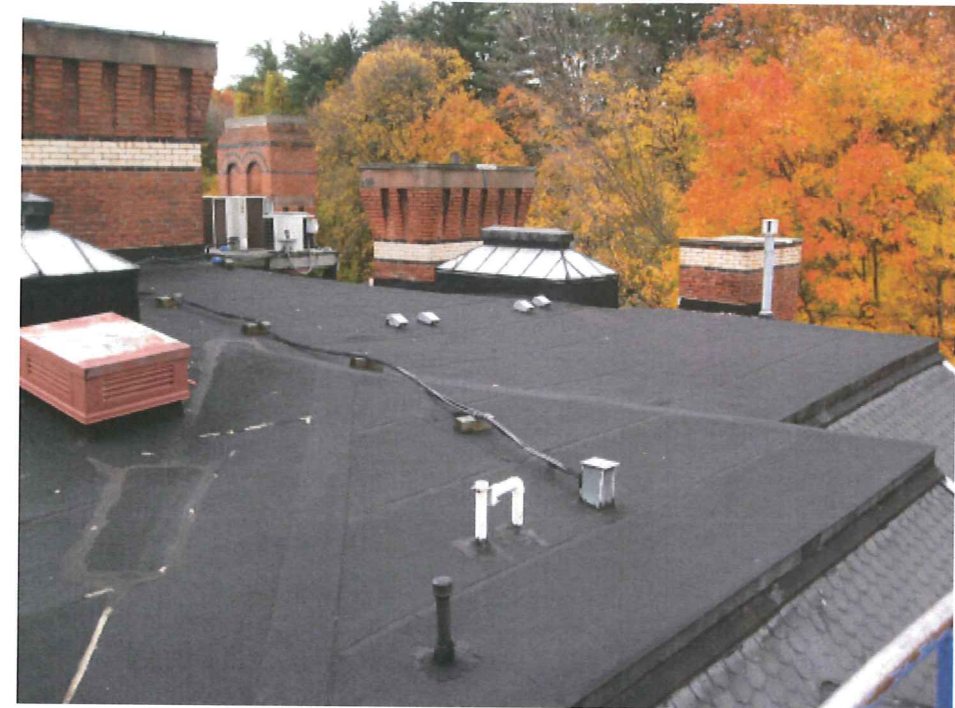
Main
roof

covered with bituminous roll roofing exhibiting multiple repairs and patches.

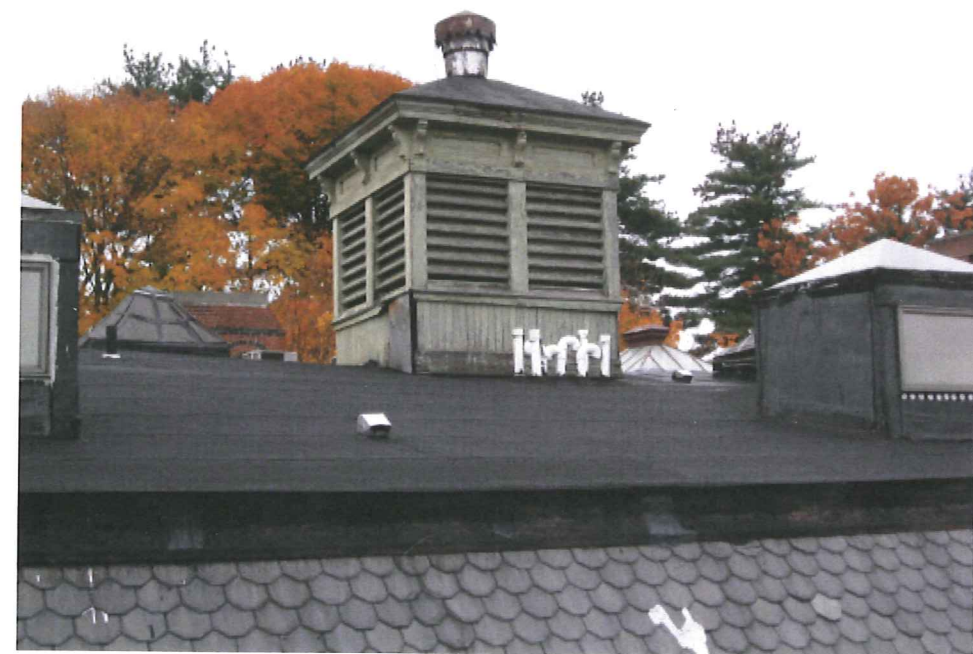
Deteriorated wooden roof monitors

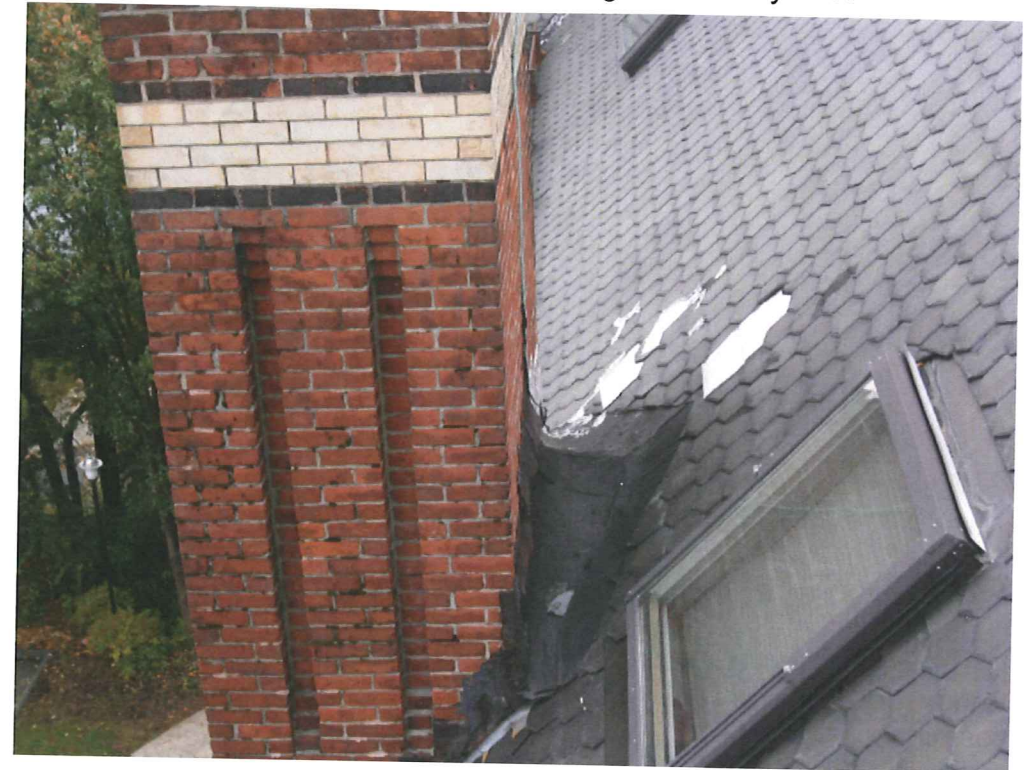
Missing and broken roof slates on low roof with failed flashings

Broken and missing roof slates, failed flashing on chimney base

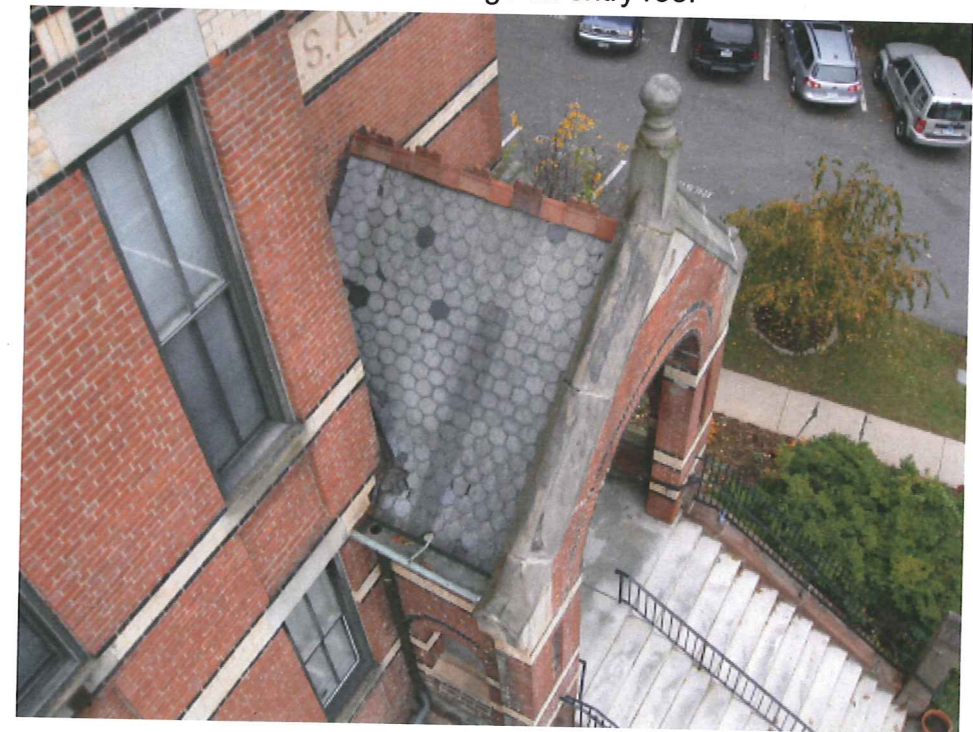
Broken roof slates and failed flashings on entry roof

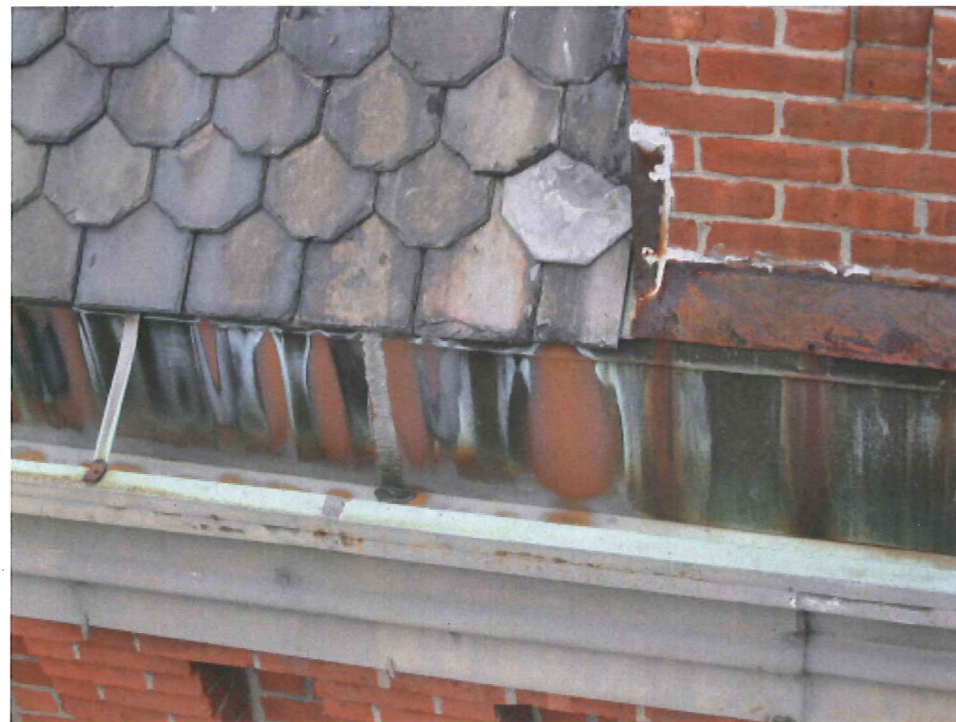
Annex roof with asphaltic coating over original tin roofing, multiple failures at seams and penetrations

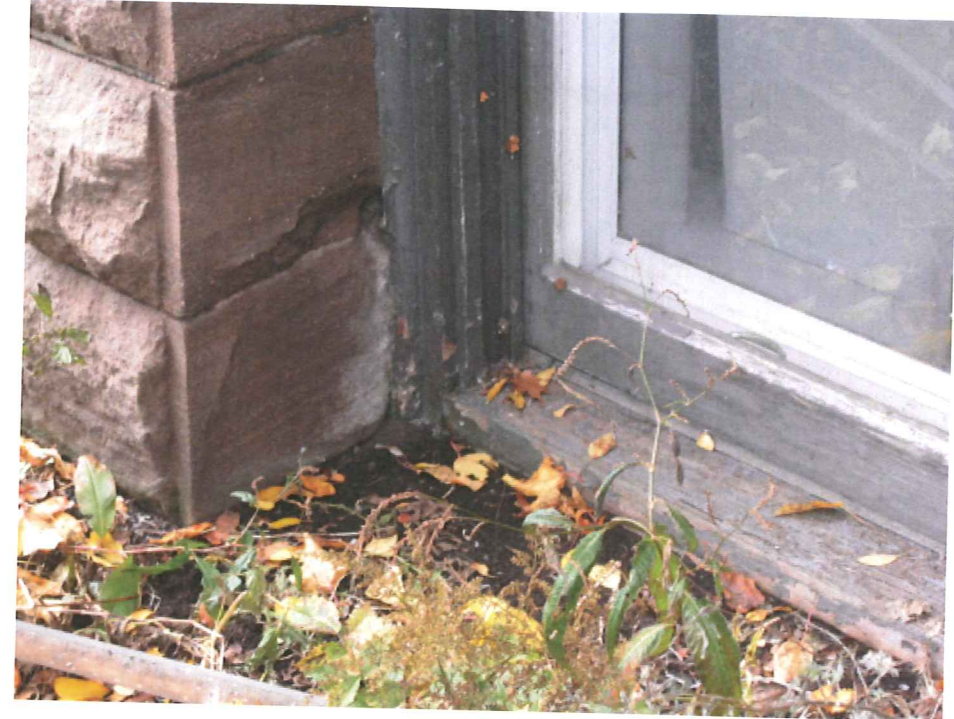
Deteriorated copper flashing and gutter lining, seam failure with material decomposition

Saturated Brownstone window surround, material failure with moisture penetration into apartment

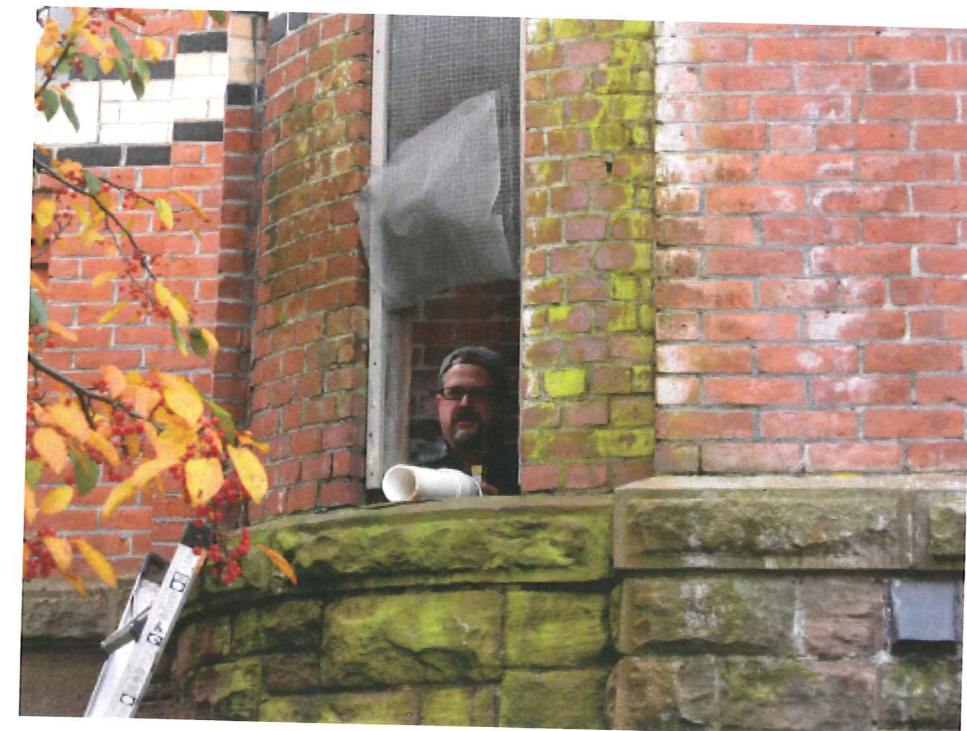
Structural Engineer examining deteriorated masonry inside the gravity ventilation shaft way enclosure
